LANDSLIDES AND RELATED FEATURES

OF THE JULIAN, W.VA. QUADRANGLE

by GREGORY C. UHLMACHER

U.S. Geological Survey OPEN FILE MAP 83-80 (B-2)

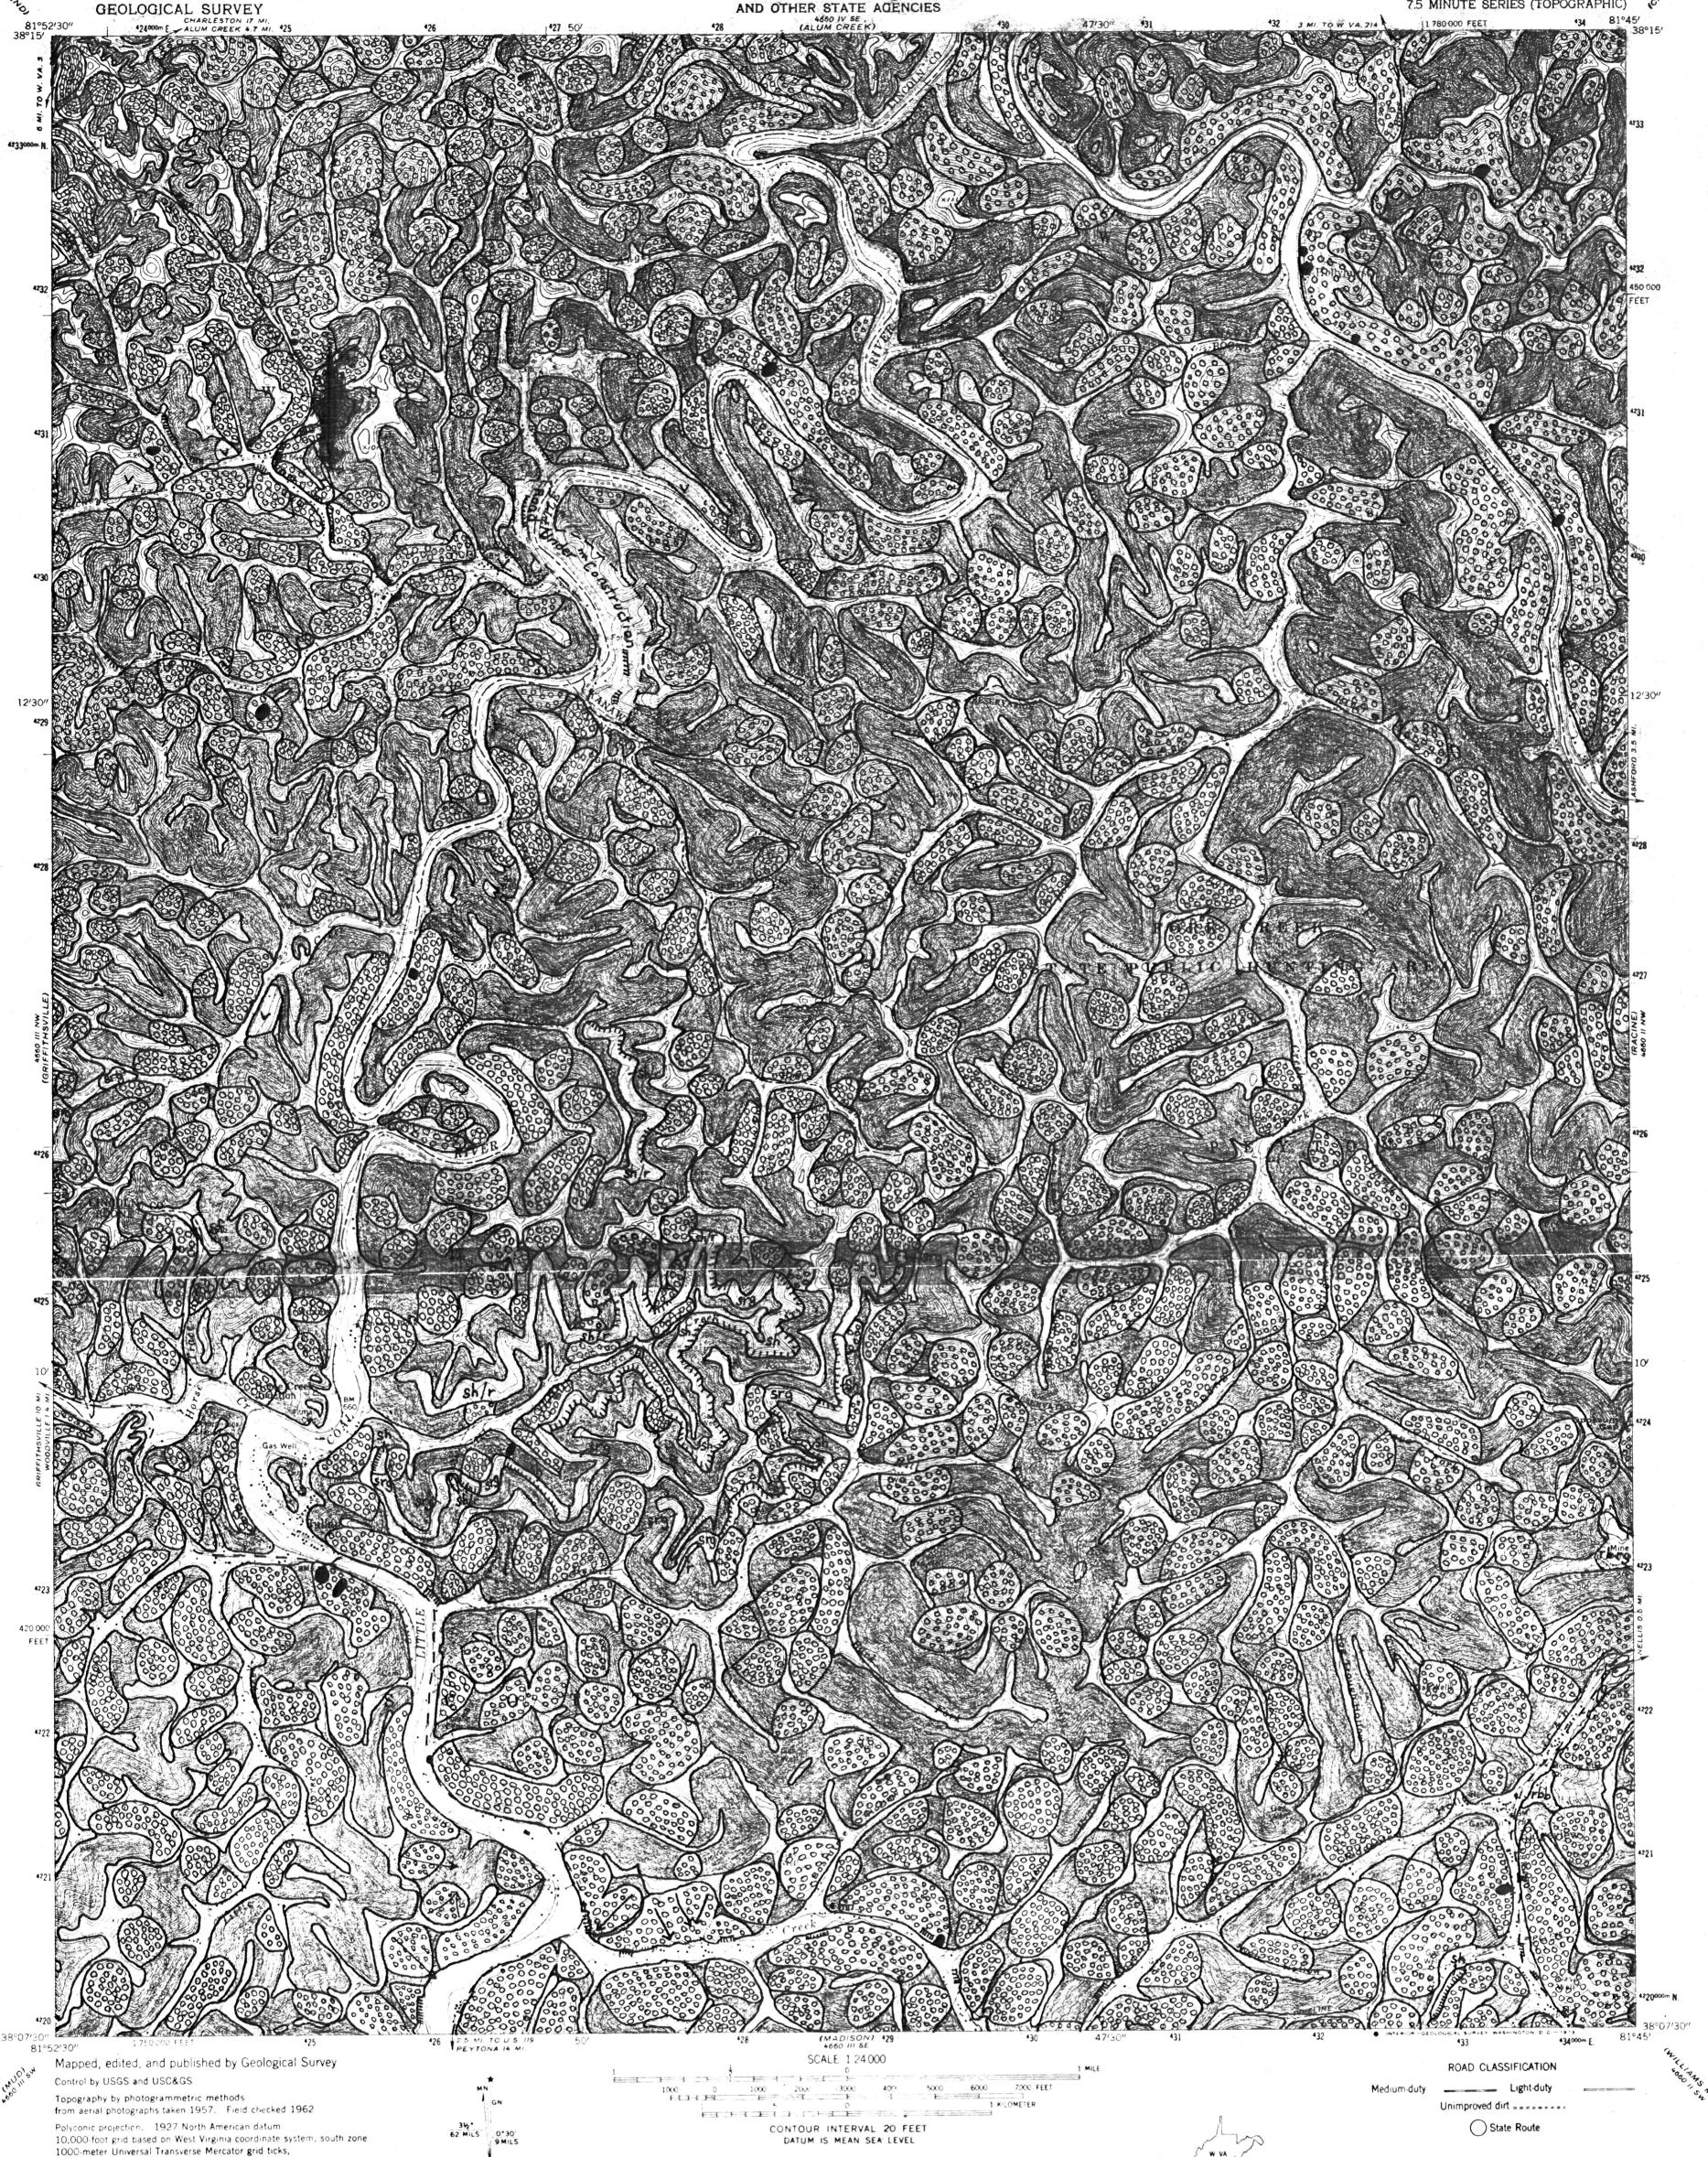
Landstides and related features interpreted from aerial photographs: 1:60,000 SCALE BLACK AND WHITE 1960 1:125,000 SCALE COLOR INFRARED 1973 1:80,000 SCALE BLACK AND WHITE 1976

Photointerpretation and field check 1979. This map has not been edited or reviewed for conformity with Geological Survey standards and nomenclature.
